Windstorm Mitigation Report (OIR-B1-1802)

Whispering Woods Homeowner's Assn, Inc. of Pinellas County
1994 Whispering Way
Tarpon Springs, FL 34689

As of 04-30-2024 | FPAT File# REN2422219

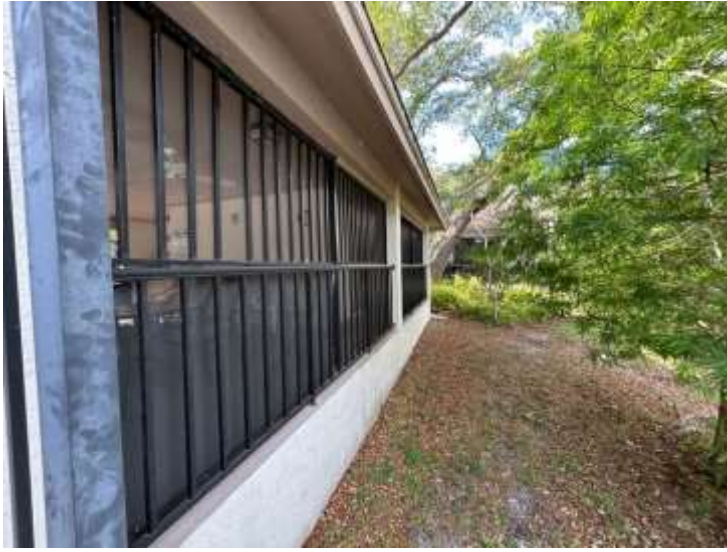
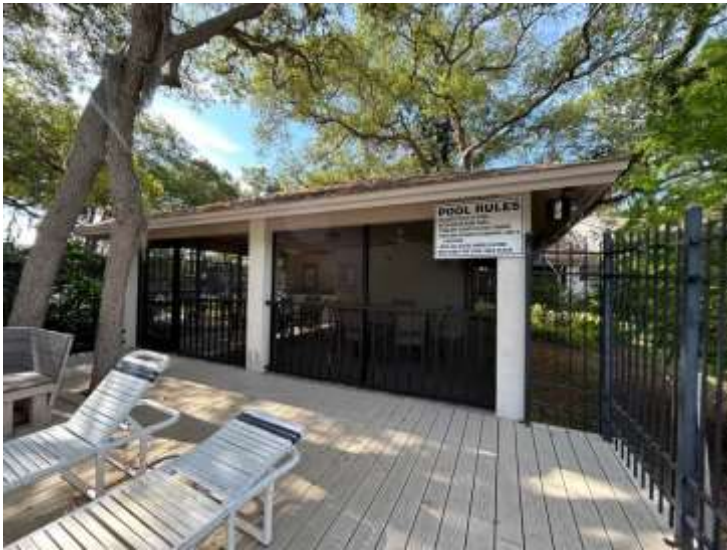
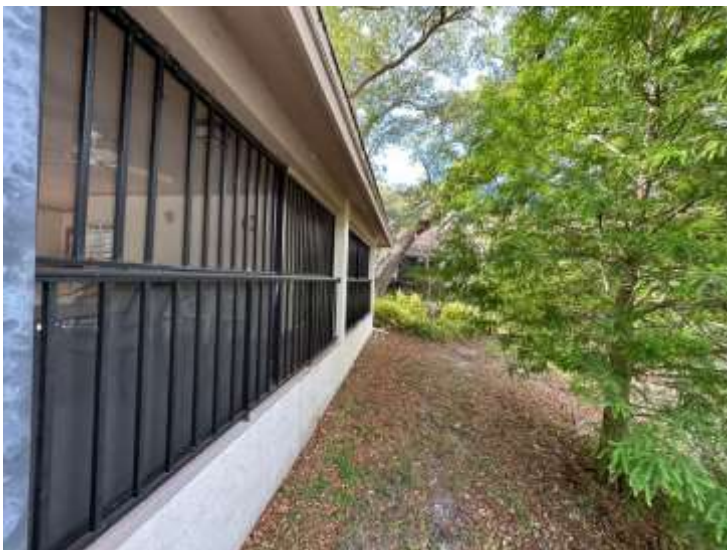
Exterior Elevation

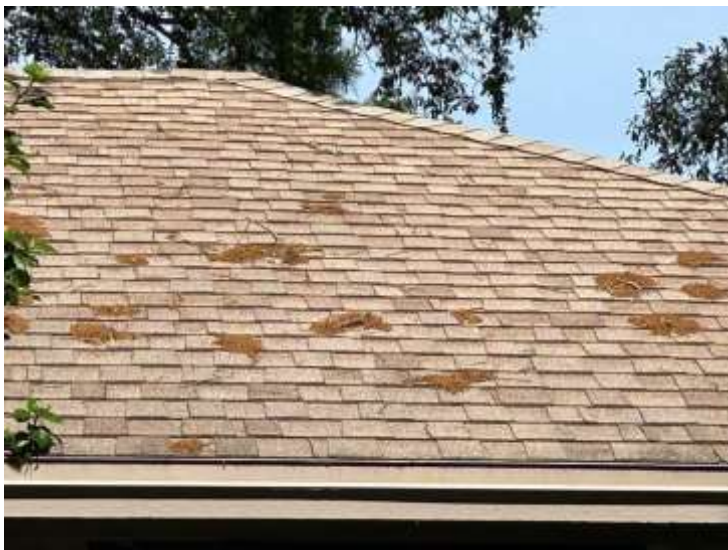
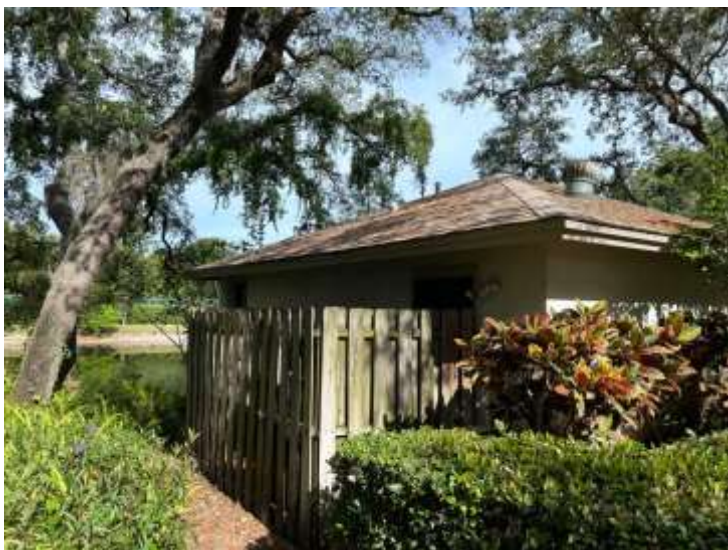
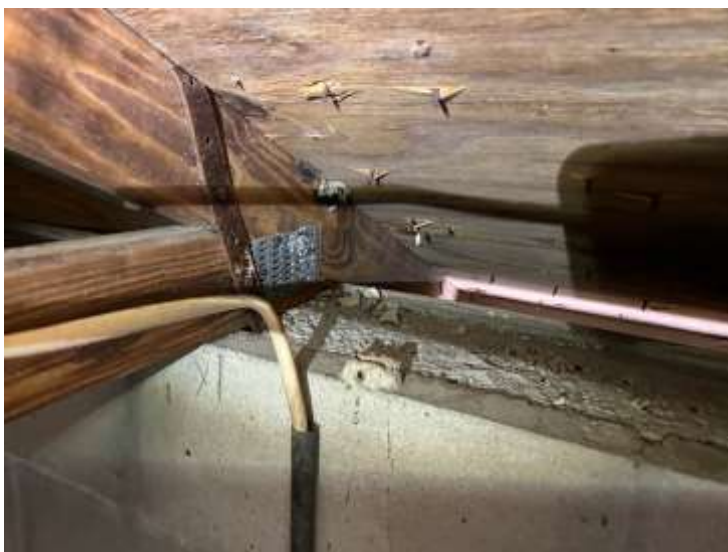
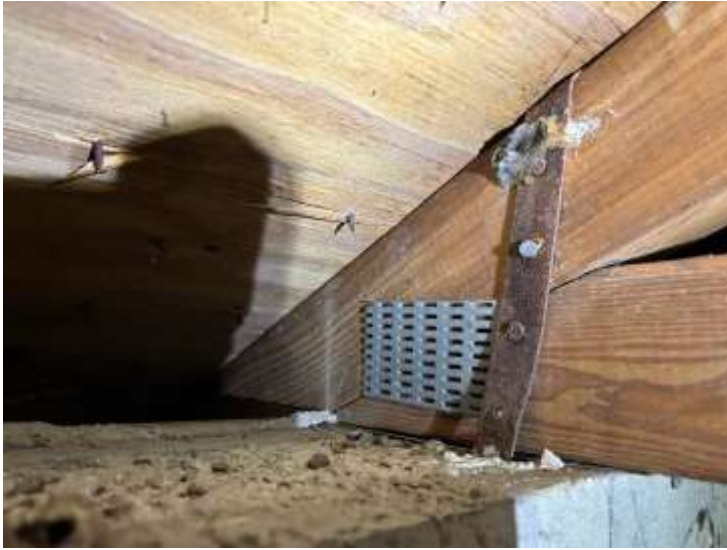
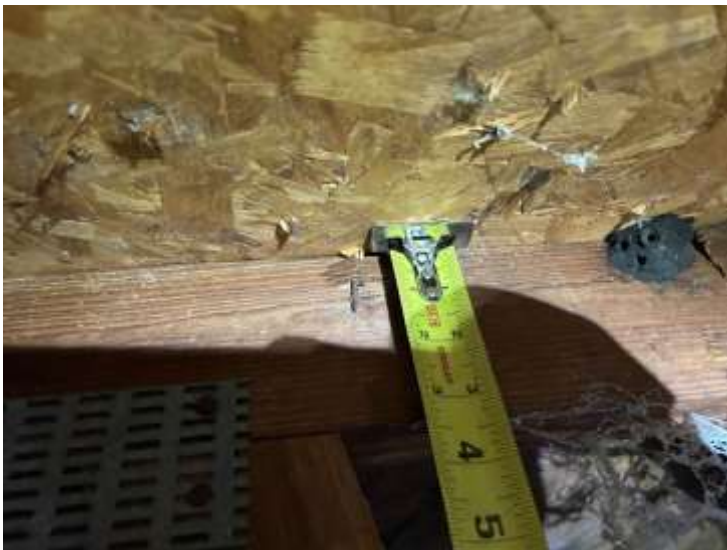
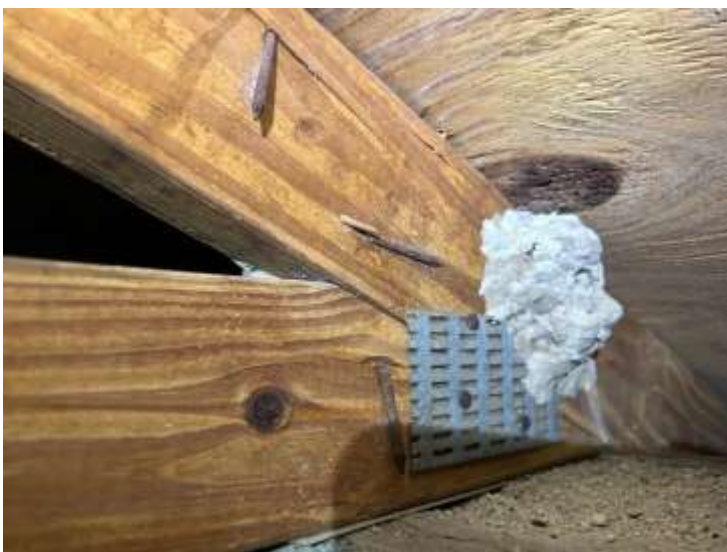
- 3. Roof Deck Attachment:** **Level A**
Comments: Inspection verified 1/2" plywood roof deck attached with 6d nails at a minimum of 6" on the edge & 12" in the field.

- 4. Roof to Wall Attachment:** **Clips**
Comments: Inspection verified embedded straps fastened with a minimum of three nails.
- 5. Roof Geometry:** **Hip Roof**
Comments: Inspection verified a hip roof shape.

Roof Construction
